Manhole Inspection Summary

Manhole # S21EE_036MH

Location Address: **1342 N FULTON AVE**

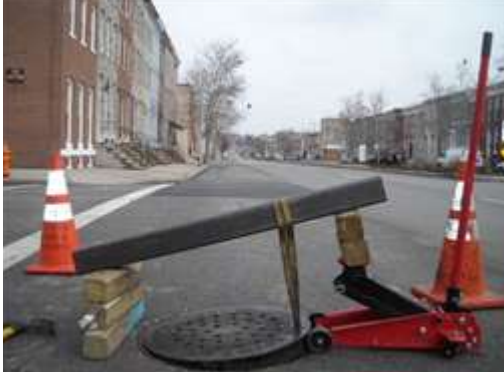
Location View

OPENED USING JACK AND BOLT METHOD - LOOKING NORTH ON FULTON AVE

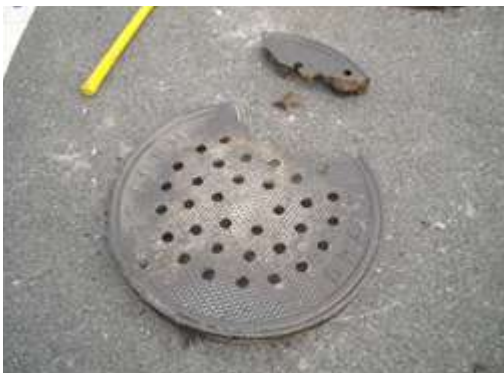
PRIOR LID WAS BROKEN

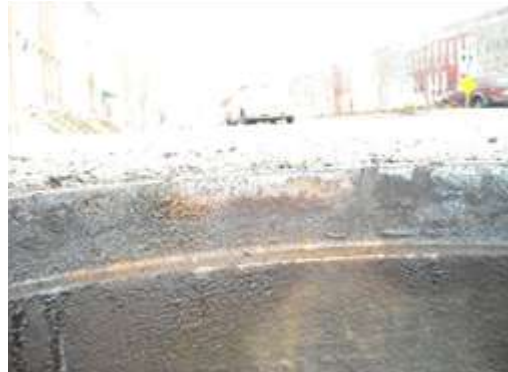
Subject To Ponding: **Sheeting**

EVIDENCE OF INFILTRATION DUE TO SHEETING FROM ROADWAY, ALSO OLD MANHOLE LID WAS VENTED

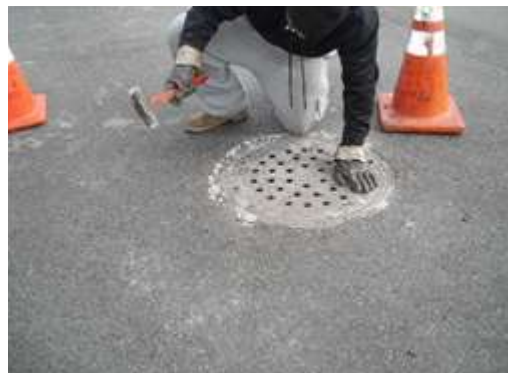
PRIOR MANHOLE

LID WAS SEALED IN ASPHALT - REMOVED ASPHALT AROUND FRAME WITH HAMMER

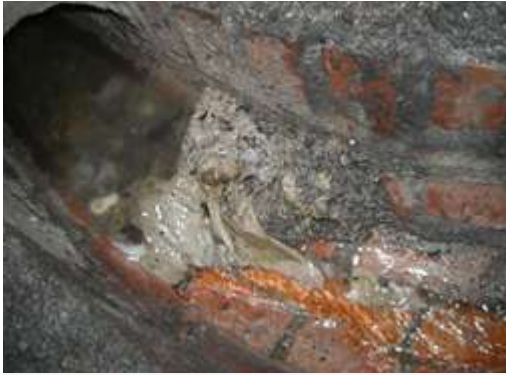
Defect 3

Condition: ☐ Sound ☐ Cracked ☐ Root Intrusion ☐ Deteriorated ☐ Leaks ☒ **Debris**

DEBRIS IN CHANNEL

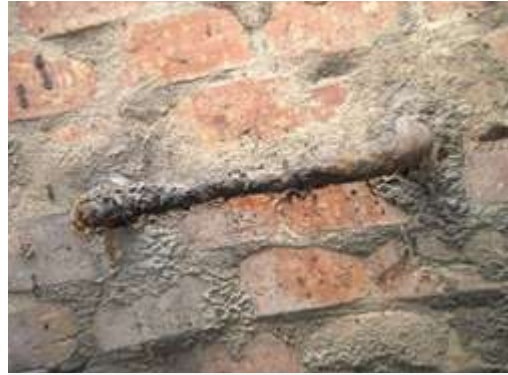
Defect 2

Steps Count: **5** Missing: **0** ☒ **Corroded**

CORRODED STEP

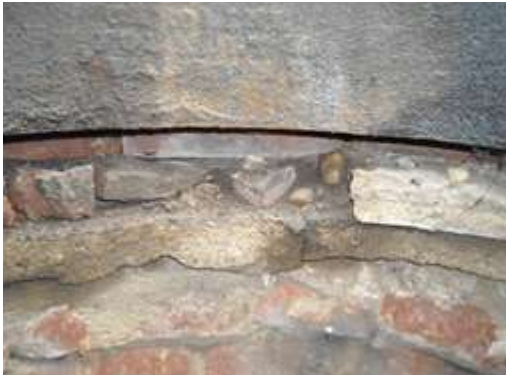
Defect 1

Condition: ☐ Sound ☐ Cracked ☐ Root Intrusion ☒ **Loose Brick** ☒ **Deteriorated**

DETERIORATED CHIMNEY
ADJUSTMENT WITH MISSING
BRICKS/STONE

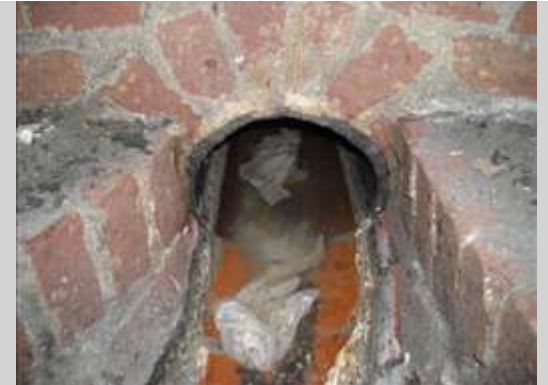
12 O'Clock Outflow

Pipe Height: **9.6** (in.) Rod and Bar (Angled)
Pipe Material: **Clay** ☐ Pipe Lined
Invert Depth: **8.64** (ft.) Flow Characteristics: **Slow**
Deposits: ☒ None ☐ Mud ☐ ~~Gravy~~ ☐ Debris ☐ Grease
Silt Depth: (in.) Deposits Extent:
Infiltration: **None** Pipe Seal Cond: **Sound**

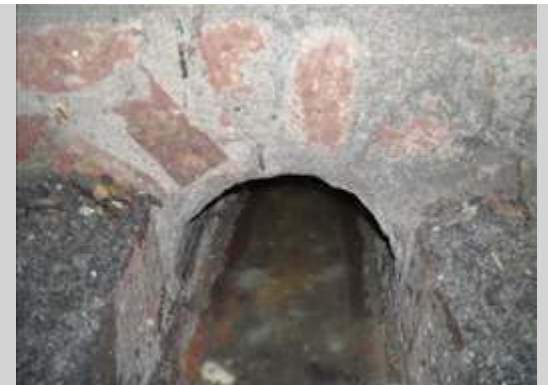
9 O'Clock Inflow

Pipe Height: **8.4** (in.) Rod and Bar (Angled)
Pipe Material: **Clay** ☐ Pipe Lined
Invert Depth: **8.30** (ft.) Flow Characteristics: **Slow**
Deposits: ☐ None ☐ Mud ☒ ~~Gravy~~ ☒ Debris ☐ Grease
Silt Depth: **2** (in.) Deposits Extent: **Light**
Infiltration: **None** Pipe Seal Cond: **Sound**
